REAL ZERO CASE STUDY 1

Refrigeration Systems in the Retail Sector

Supermarket Site Survey Case Study

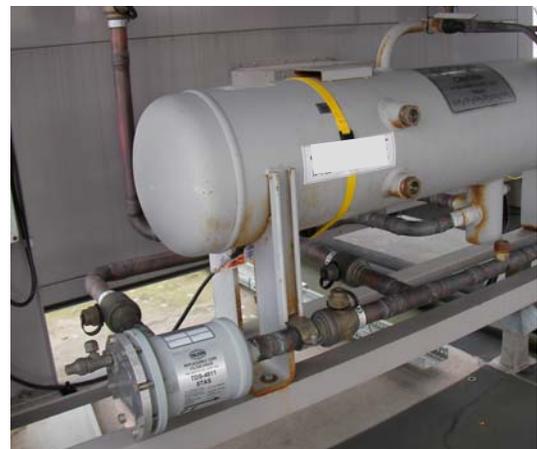
Leak testing was carried out using hand held leak detectors that were capable of detecting leakage rates as low as 5g/ year. New leaks found included a significant leak in the Schrader valve used for charging refrigerant on the end housing of the liquid line filter drier, a leaking Pressure Relief Valve (PRV) and a leaking flare joint at the inlet to a filter drier. Additionally there was visual evidence of past leakage from a Receiver outlet valve and a drier outlet, as evidenced by oil stains. Caps were missing on several valves and bolts were also missing in some locations. Recommendations were made to the client for the repair of leaks, replacement of missing bolts and the fitting of caps to all valves.
